# Integrated Precision Battery Sensor for Automotive System

Silicon Anomaly

ADuC7033

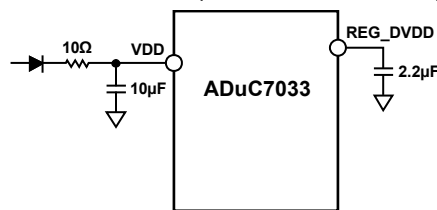
Figure 1.

<b>Background:</b>	The ADuC7033 integrates a power-on reset (POR) circuit holding the ASIC in reset for 20 ms typically after VDD reaches 3 V typically.
<b>Issue:</b>	Under particular conditions, the POR does not release the reset signal, that is, the ASIC remains in reset until a power cycle occurs. This POR issue only occurs under three specific and coincident power-on conditions: <ul style="list-style-type: none"> <li>• Fast ramp on VDD, nominally faster than 100 <math>\mu</math>s from <math>V_{init}</math> to 12 V</li> <li>• Initial value of VDD (<math>V_{init}</math>) <math>\sim</math>1.2 V</li> <li>• Voltage on REG_DVDD at time the VDD ramp is reapplied <math>\sim</math>175 mV</li> </ul>
<b>Workaround:</b>	A fast VDD ramp (that is, ramping from $\sim$ 1.2 V to 12 V in $<$ 100 $\mu$ s) is required as one of the conditions to initiate the reported POR issue. Analog Devices recommends careful selection of external power supply decoupling components to ensure that the VDD supply ramp rate can always be guaranteed to be $>$ 100 $\mu$ s under all VBAT power-on conditions. Specifically, in modules that already incorporate a series resistor and decoupling capacitor to ground on the VDD line between the reverse protection diode and the VDD pin (see Figure 1), choose the series resistor/decoupling capacitor combination to give an RC time constant of at least 100 $\mu$ s, such as 10 $\Omega$ and 10 $\mu$ F.

Alternatively, in the specific case of customer modules where the VDD decoupling capacitor cannot be increased beyond 4.7  $\mu$ F, then increasing the series resistor to 20  $\Omega$  and increasing the REG\_DVDD decoupling capacitor from 2.2  $\mu$ F to 10  $\mu$ F also slews the VDD supply power-on ramp to  $\sim$ 200  $\mu$ s. This is also an appropriate and recommended containment measure.
