Active Errata List

Lot Number	Errata List
M67206H, M672061H, M67204H all lot numbers	1, 2

Radiation Tolerant FIFOs

M67206H M672061H M67204H Errata Sheet

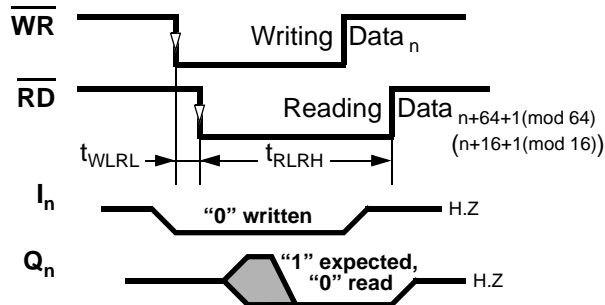
Sometimes a bit that has been written "1" is read "0".

1. Read and write commands fall down almost at the same time, t_{WLRL} parameter in the hereunder table.
2. Write bit "0" on input port while a bit "1" is expected on output port.
3. Reading the $64^{th}+1 \pmod{64}$ location ($16^{th} + 1 \pmod{16}$) for 4Kx9 FIFO) vs. the writing location.
4. Read pulse (t_{RLRH}) less than the one specified in the hereunder table.

The memory array of the 16Kx9 FIFO contains 64 columns, the 4Kx9 contains 16 columns. To reduce the read access time, a pipe line has been implemented on the data path. When the data_n is going out of the FIFO, the data_{n+1} is pre-fetched for the next read access. When the internal writing and reading are different from $64 \pmod{64}$ ($16 \pmod{16}$), a write and a read access are made on the same column. Coupling between the read bit-line and the write bit-line only disturbs the pre-fetch operation, forcing the sense amplifier to output "0". Then, the next external reading may be wrong.

1. No read sequence while write sequence.
2. Control the distance between the read and write locations.
3. Control the t_{WLRH} parameter in accordance with the above table.
4. Apply a read pulse t_{RLRH} greater than the value given in the above table.

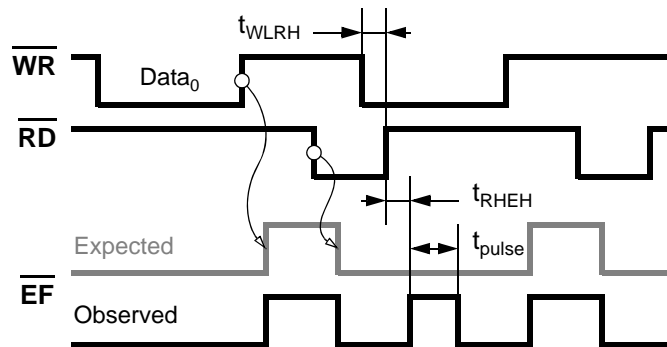
1. \overline{WR} wide pulse width:

A parasitic positive pulse can be observed during a FIFO write if it is applied during the read of first data of the FIFO buffer (c.f. hereunder chronograms).

Un-controlled delays on input signals of a flags logic decoder generate an internal glitch. This glitch is re-formatted by the on-chip ETD system (Edge Transition Detection) and a parasitic pulse is output on \overline{EF} pin.

1. No write sequence while read sequence.
2. \overline{EF} evaluation according to the following characterization.

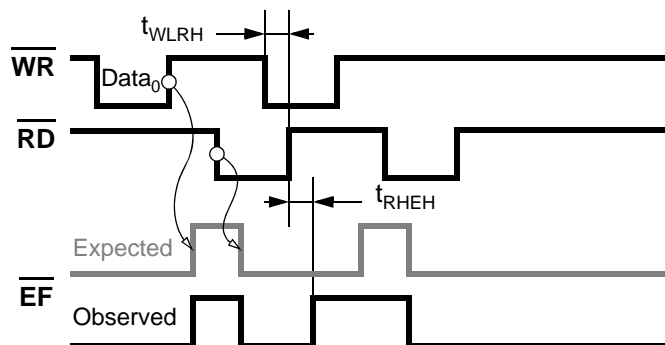
2. \overline{WR} short pulse width:

In this case, the falling edge of the parasitic pulse is masked by the beginning of the regular high level of \overline{EF} flag.
