Errata on AT91SAM9G45 Engineering Sample Devices

This document describes the known errata found on Atmel's AT91 ARM® Thumb®-based Microcontroller series **AT91SAM9G45** device engineering samples with a date code prior to 0927.

AT91SAM9G45

Errata Sheet

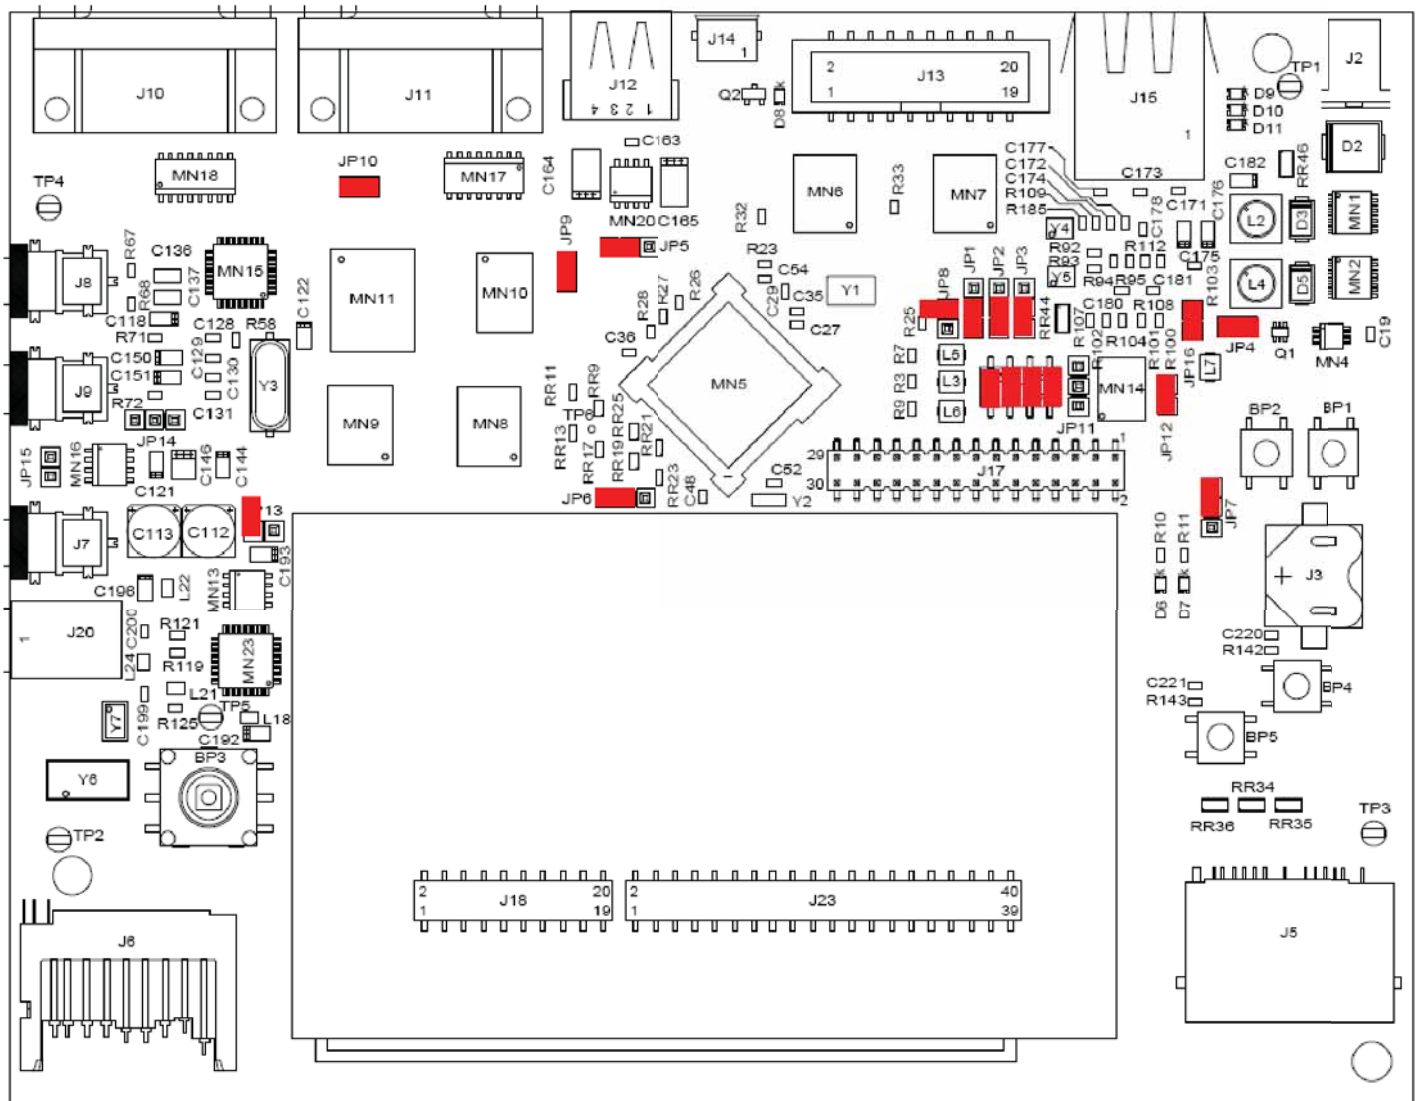
Figure 2-1. Default Jumpers Settings

Prior to any operation, the user needs to install *AT91-ISP.exe 1.13* and unzip [AT91SAM9G45_RomCode_Replacement.zip](#) file that contains a version of ROM binary code with USB issue fixed. Check and conform to the following Default Jumpers Settings.

Once done, the following steps are necessary to store this version of ROM code in DataFlash.

1. unplug power supply
2. unplug USB device cable
3. remove jumper JP10 (NandFlash Chip Select) & JP12 (DataFlash Chip Select)
4. plug serial cable
5. launch hyper terminal (115,200 bauds, 8 bits, parity none, 1 stop bit, no flow control)
6. plug-in power supply
7. type on hyper terminal: "Alt-0128 Alt-0128 #"
8. AT91SAM9G45-EKES returns ">"
9. close hyper terminal
10. close jumper JP12 (DataFlash® Chip Select)
11. launch SAM-BA (Choose right COM port and AT91SAM9G45-EKES)
12. choose DataFlash media tab in the SAM-BA GUI interface

13. initialize DataFlash, choosing the Enable action in the Scripts rolling menu and press Execute
14. choose Send boot file, press Execute
15. select *AT91SAM9G45_RomCode_Replacement.bin* binary file and press Open; the media is written down
16. close SAM-BA
